Home Inspection Report

555 Main Street

Anywhere , FL 00000

Inspected on Thu, Sep 17 2020 at 10:00 AM

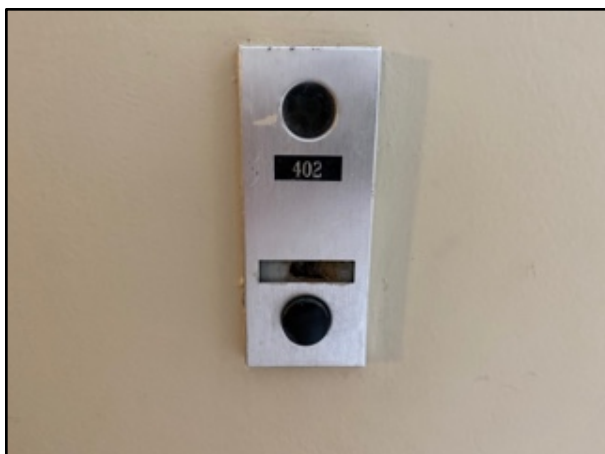
Figure 1-1

Comment 1:
Unit 402.

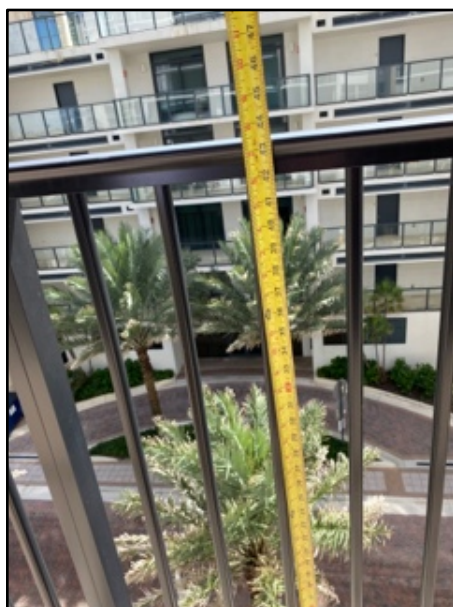
Figure 2-1

i Comment 2:
Outside Railing secure with guard height an baluster spacing within satisfactory range.

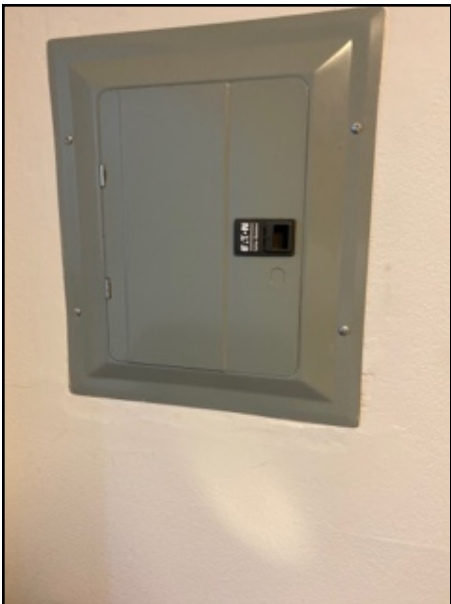
Figure 3-1

i Comment 3:
Main panel located in kitchen .

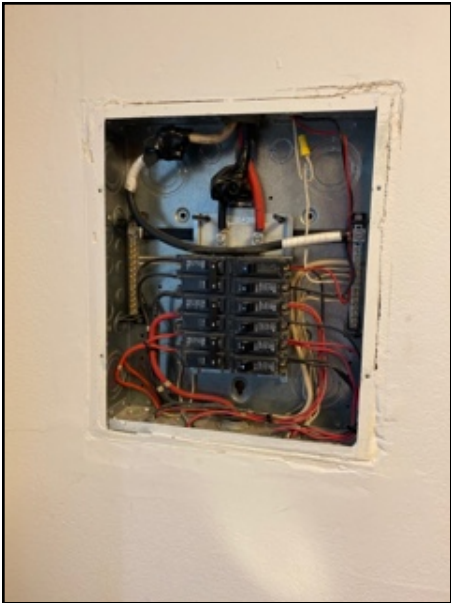
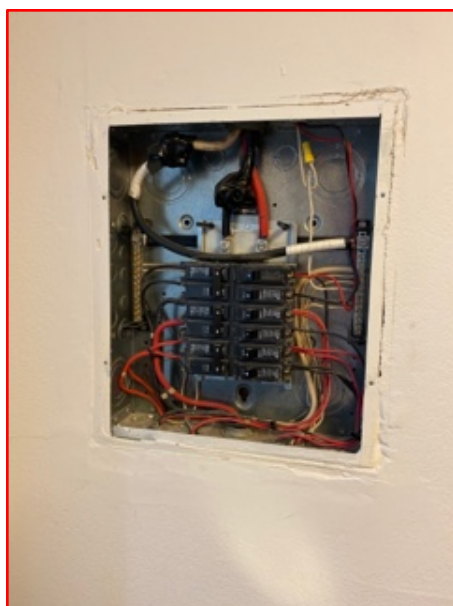
Figure 4-1

**Comment 4:**
Splices at the power from the meter , and two double tapped breakers . I recommend correction from a licensed electrical contractor.

1) Splices at the power from the meter , and two double tapped breakers . I recommend correction from a licensed electrical contractor.

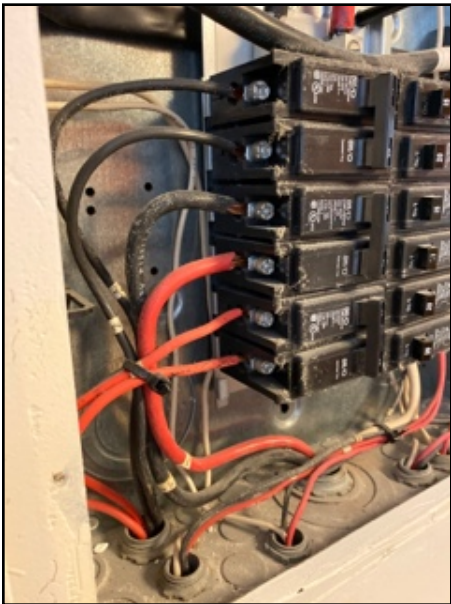
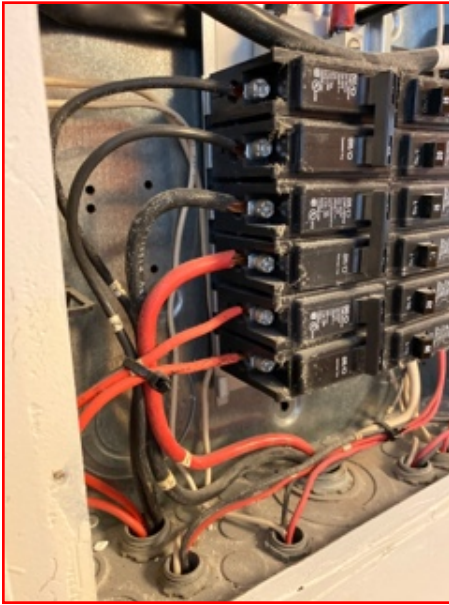
Figure 6-1

Comment 6:
Splice service entrance and double tapped breakers.

3) Splice service entrance and double tapped breakers.

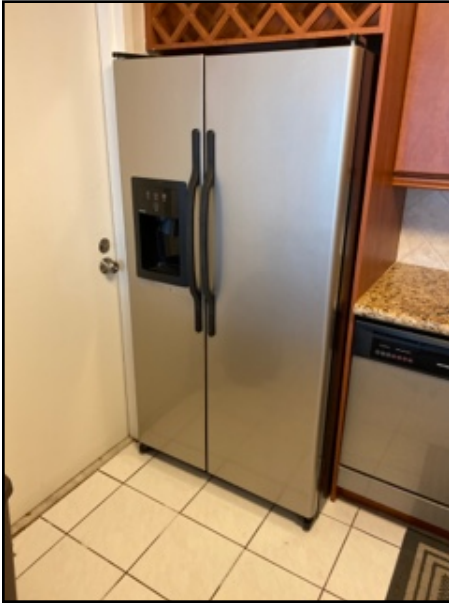
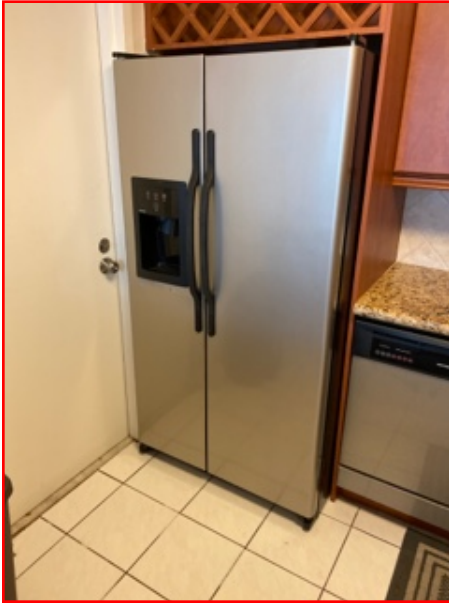
Figure 16-1

Comment 16:
Refrigerator defect beneath ice maker.

8) Refrigerator defect beneath ice maker.

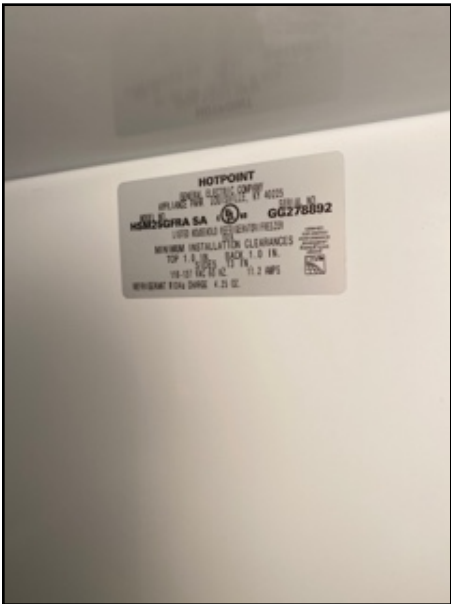
Figure 17-1

Comment 17:
Refrigerator functioned .

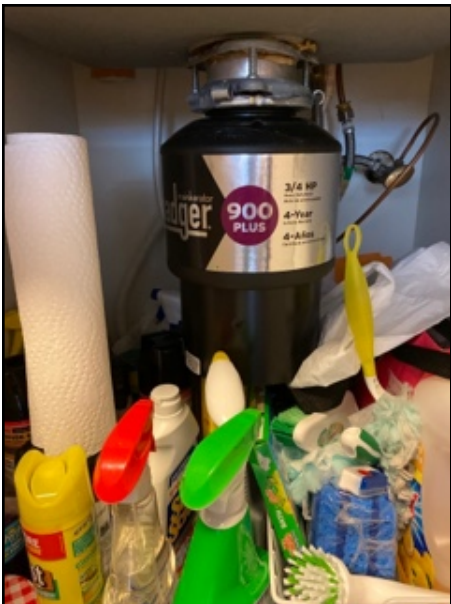
Figure 18-1

Comment 18:
Disposal functioned .

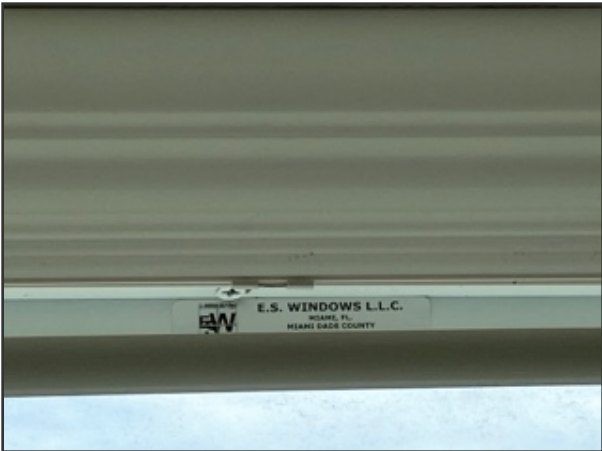
Figure 21-2

Comment 21:
Ratings for impact glass .

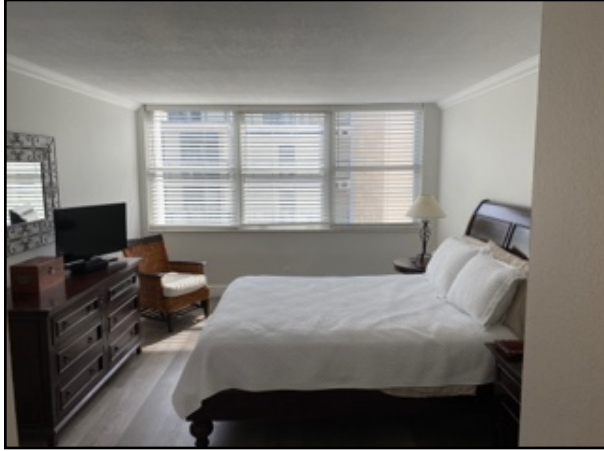
Figure 22-1

Comment 22:
Interior pic.

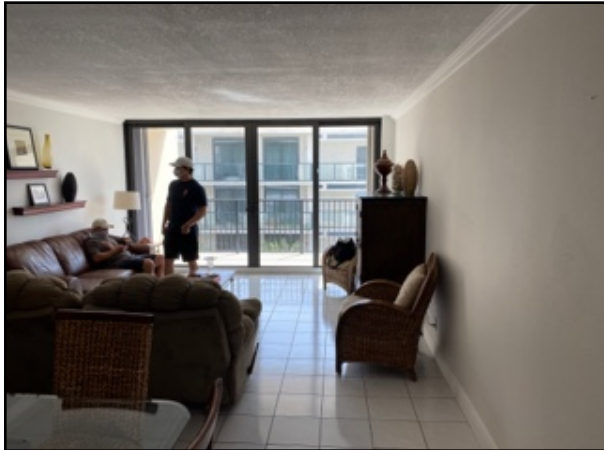
Figure 23-1

Comment 23:
Interior pic.

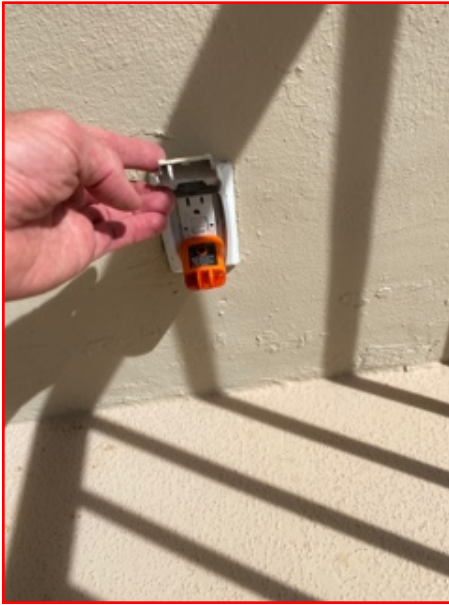
Figure 7-1

4) Outside GFCI didn't operate .
