Home Inspection Report

555 Main Street

Anywhere , FL 00000

Inspected on Thu, Sep 17 2020 at 10:00 AM

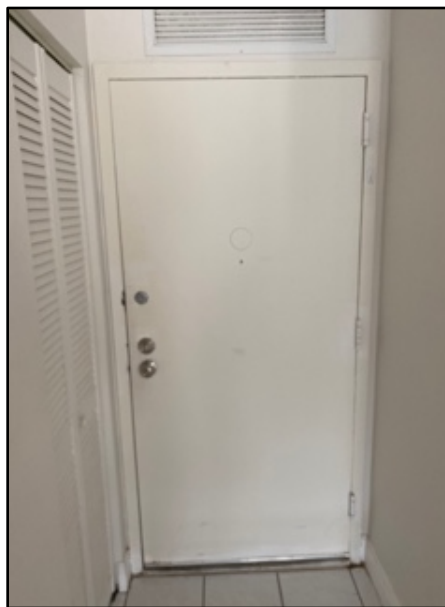
Figure 1-2

Comment 1:
Unit 402.

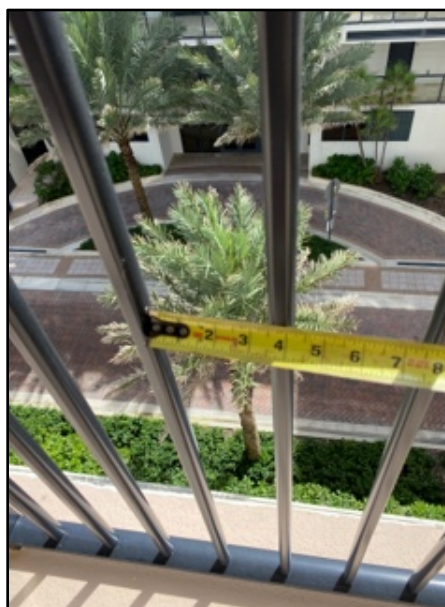
Figure 2-2

i Comment 2:
Outside Railing secure with guard height an baluster spacing within satisfactory range.

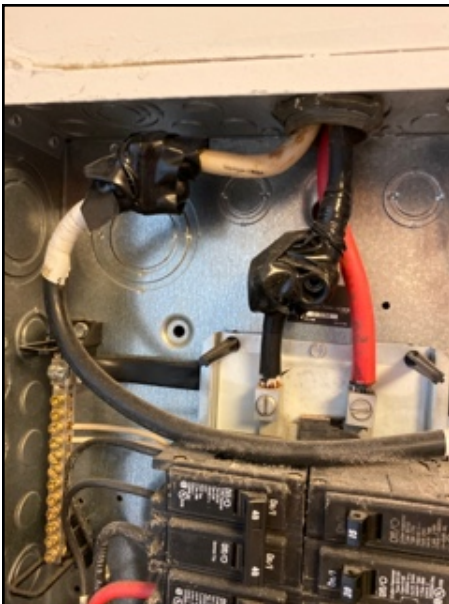
Figure 5-1

Comment 5:
Power from meter cables are spliced.

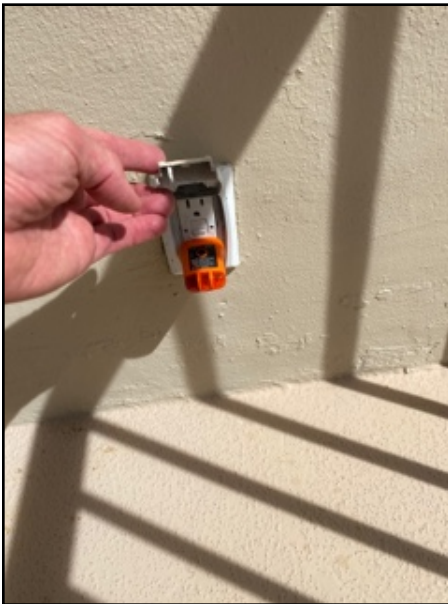
Figure 7-1

Comment 7:
Outside GFCI didn't operate .

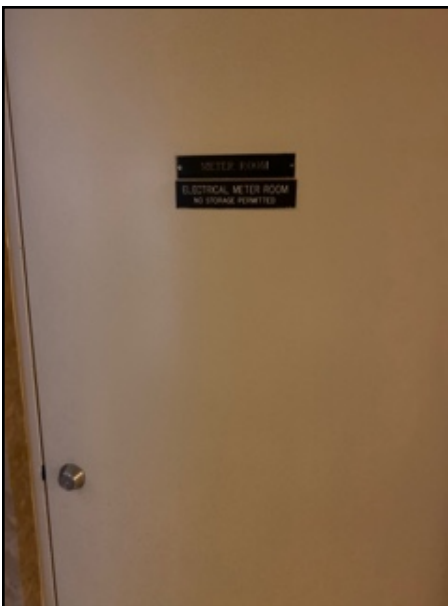
Figure 8-1

Comment 8:
Locked mechanical room across the hall. No access

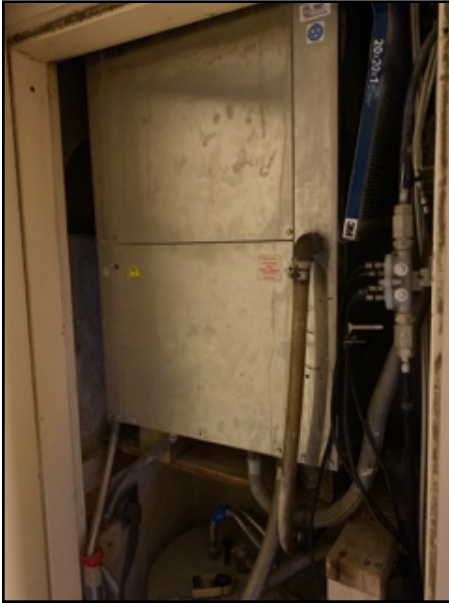
Figure 10-1

Comment 10:
HVAC unit, no labels to identify age but seemed to operate properly .

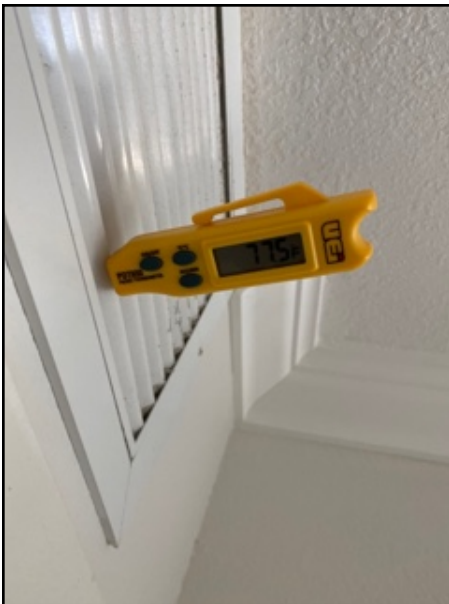
Figure 12-1

Comment 12:
Return temperature .

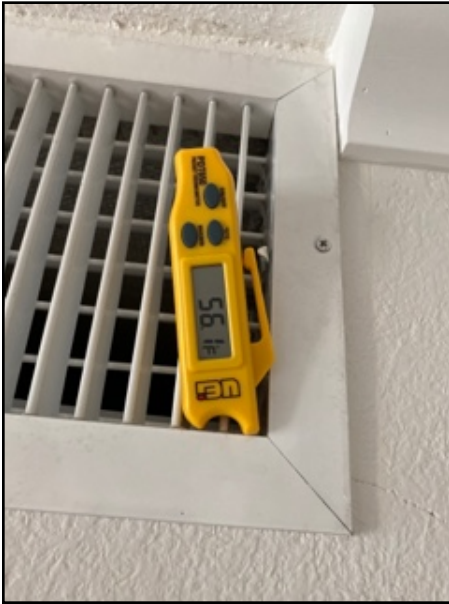
Figure 13-1

i Comment 13:
Supply temperature .
Differential temperature is 21.4 degrees - tests within acceptable range

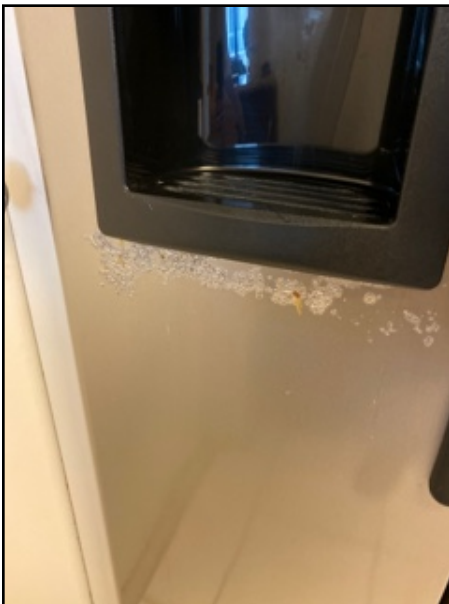
Figure 16-3

Comment 16:
Refrigerator defect beneath ice maker.

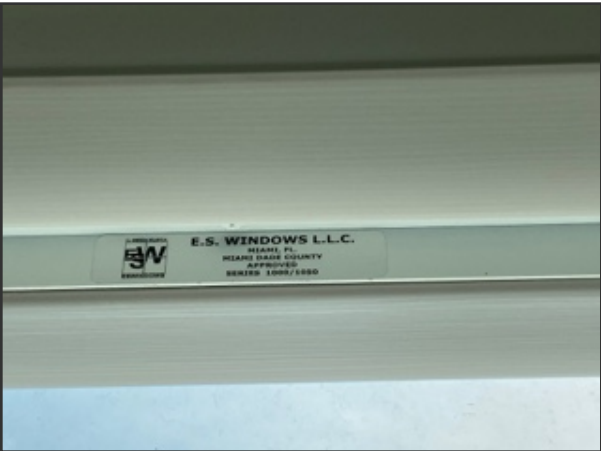
Figure 21-1

Comment 21:
Ratings for impact glass .

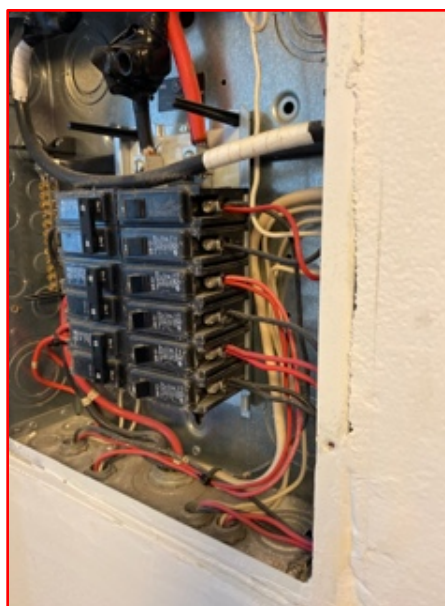
Figure 4-2

1) Splices at the power from the meter , and two double tapped breakers . I recommend correction from a licensed electrical contractor.

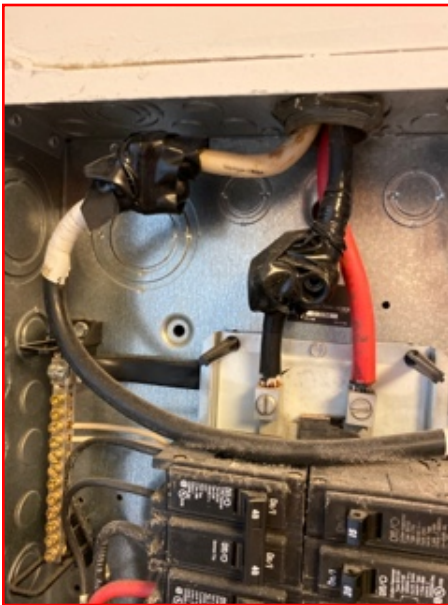
Figure 5-1

2) Power from meter cables are spliced.

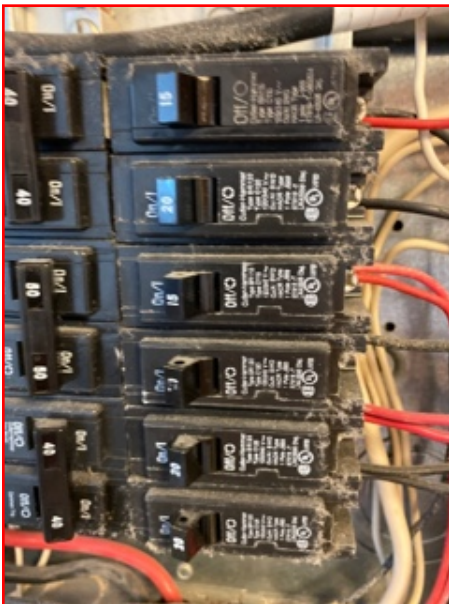
Figure 6-3

3) Splice service entrance and double tapped breakers.

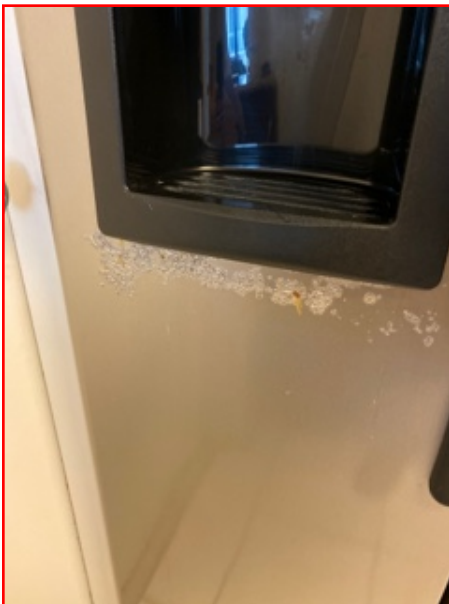
Figure 16-3

8) Refrigerator defect beneath ice maker.
